# CORNER RECORD

DPW# 18-075

APN 143-331-34

City of Novato County of Marin, CaliforniaBrief Legal Description Lot 9 of "Laguna Vista Unit One", Vol. 18 Maps 66**CORNER TYPE****COORDINATES (Optional)**

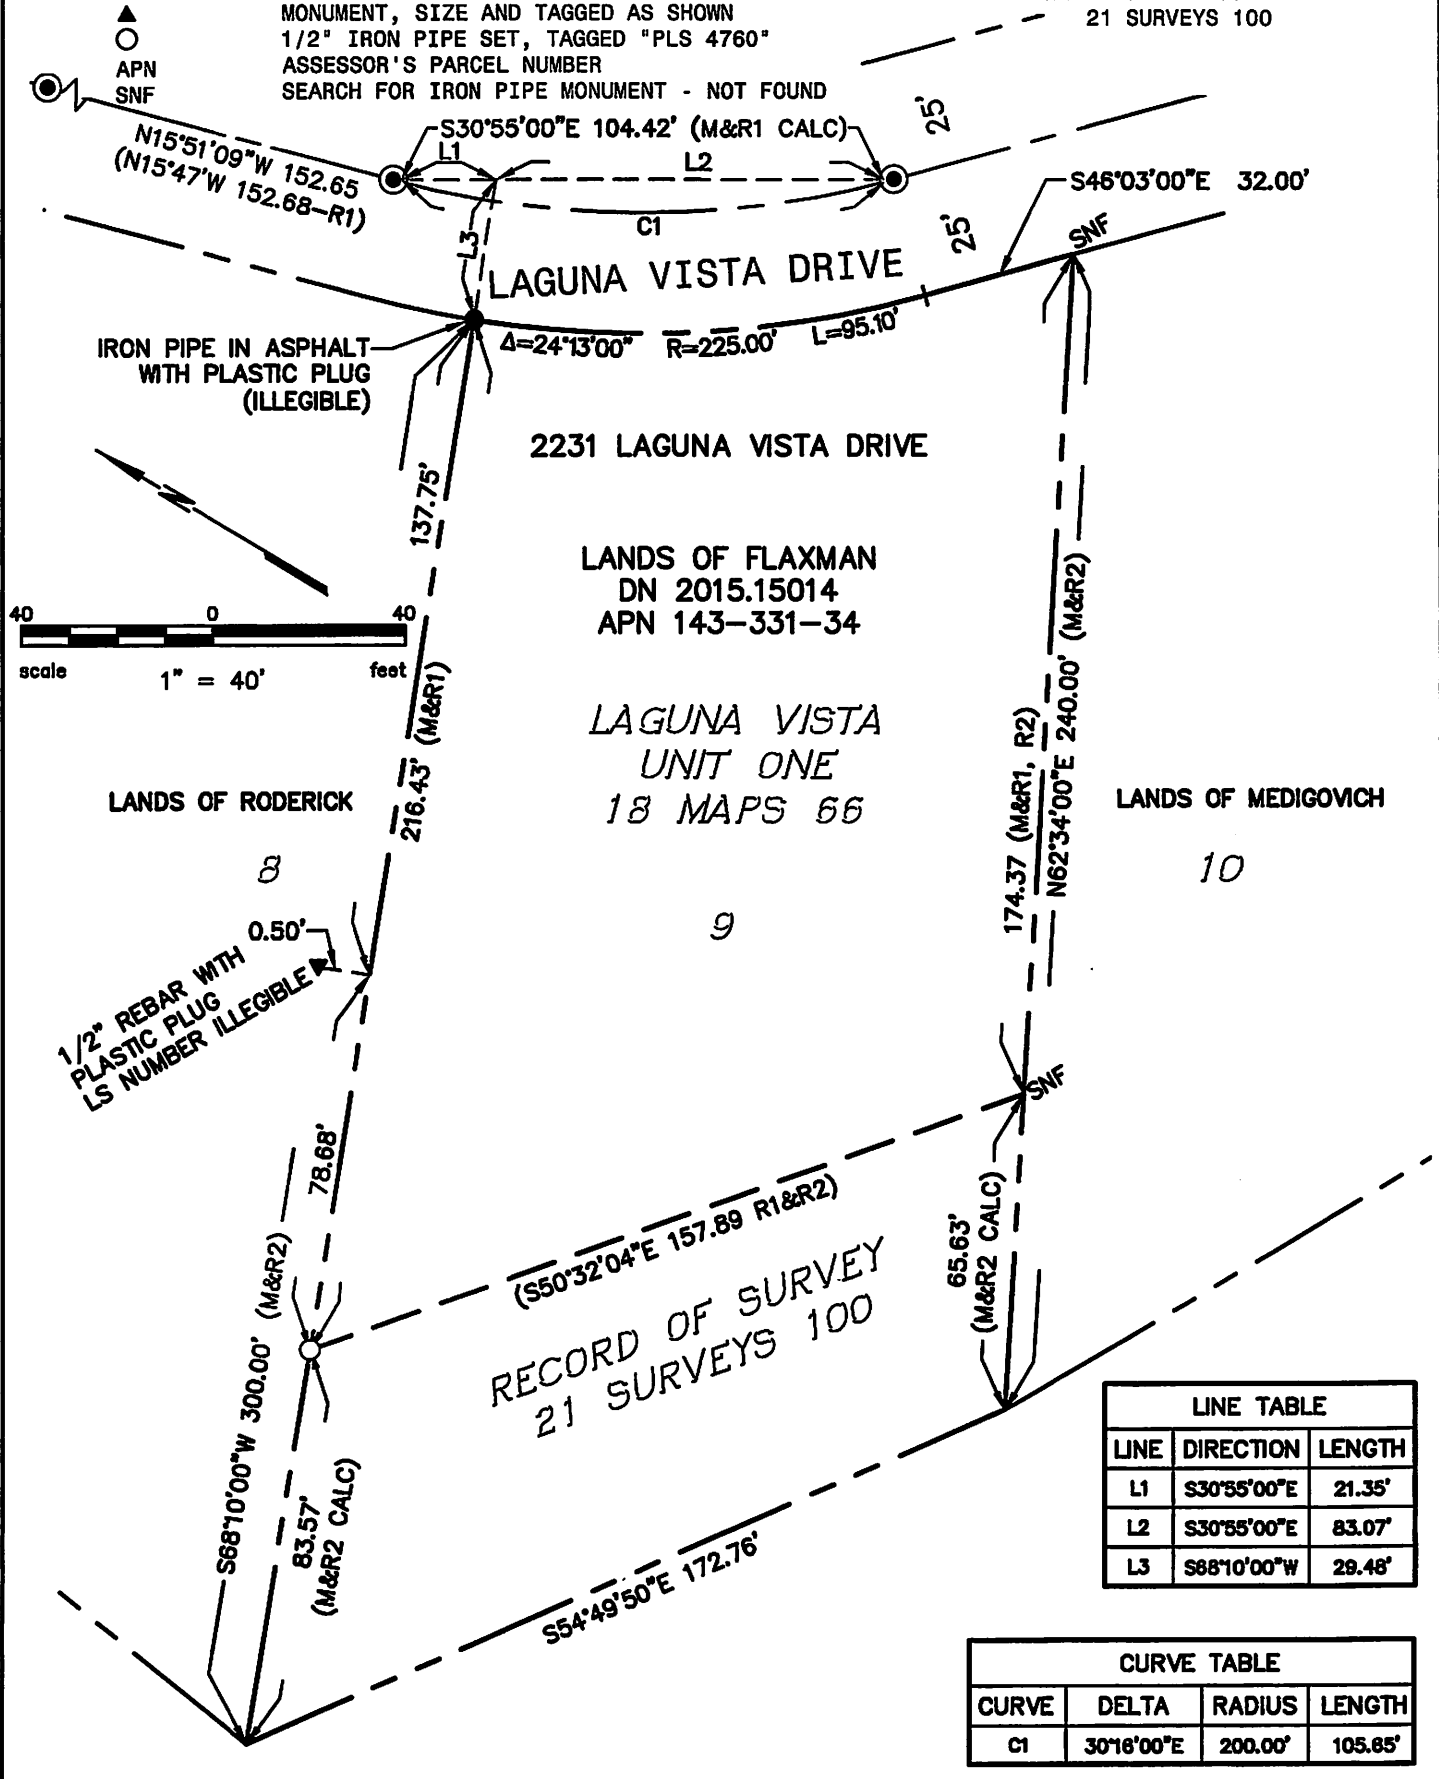
We were asked to establish the northerly boundary of Lot 9, of Laguna Vista Unit One, also being Lot 9 of that Record of Survey of the Lot Line Adjustment of the lands of Marin Vista Corporation. We surveyed the 3 monuments immediately adjacent to the line we needed to set. There seems to be about 4 minutes of angle error between the monument lines. I chose to hold the chord of the curve in front of the property (the distance measured flat). That brought the line a little closer too, but not coincident with a pipe that was found along the line, with a plug that was unreadable.

### REFERENCE DATA

2" BRASS DISK IN WELL MONUMENT FOUND, WITH PUNCH MARK -  
NO OTHER MARKINGS  
IRON PIPE FOUND, SIZE AND TAGGED AS SHOWN  
MONUMENT, SIZE AND TAGGED AS SHOWN  
1/2" IRON PIPE SET, TAGGED "PLS 4760"  
ASSESSOR'S PARCEL NUMBER  
SEARCH FOR IRON PIPE MONUMENT - NOT FOUND

R1 MAP OF LAGUNA VISTA  
UNIT ONE  
18 MAPS 66  
R2 RECORD OF SURVEY  
21 SURVEYS 100

It is the opinion of the County Surveyor that this corner record does not show that sufficient monumentation was found to set the 1/2" iron pipe monuments shown hereon, and that pursuant to the found 1/2" rebar with plastic plug, LS number illegible, a record of survey should be filed pursuant to Section 8762(b)(1) and 8762(b)(3) of the Business and Professions code.

This survey does not require that a Record of Survey be filed under the Sections cited. There is no material discrepancy, or alternate solution, from a rebar that is out of position, and is not of record. I reestablished the position of the original lot corner, given the best information available, namely, two original street monuments, and an original iron pipe found at the front lot corner.
