# CORNER RECORD

Agency Index CR24-061Document Number 052-490-08(ADJ)City of UNINCORPORATED County of MARIN, CaliforniaBrief Legal Description FND 6" DIA CONC AT CL INT OF DRAKE AVE & DONAHUE ST (RM21-042)**CORNER TYPE****COORDINATES (Optional)**

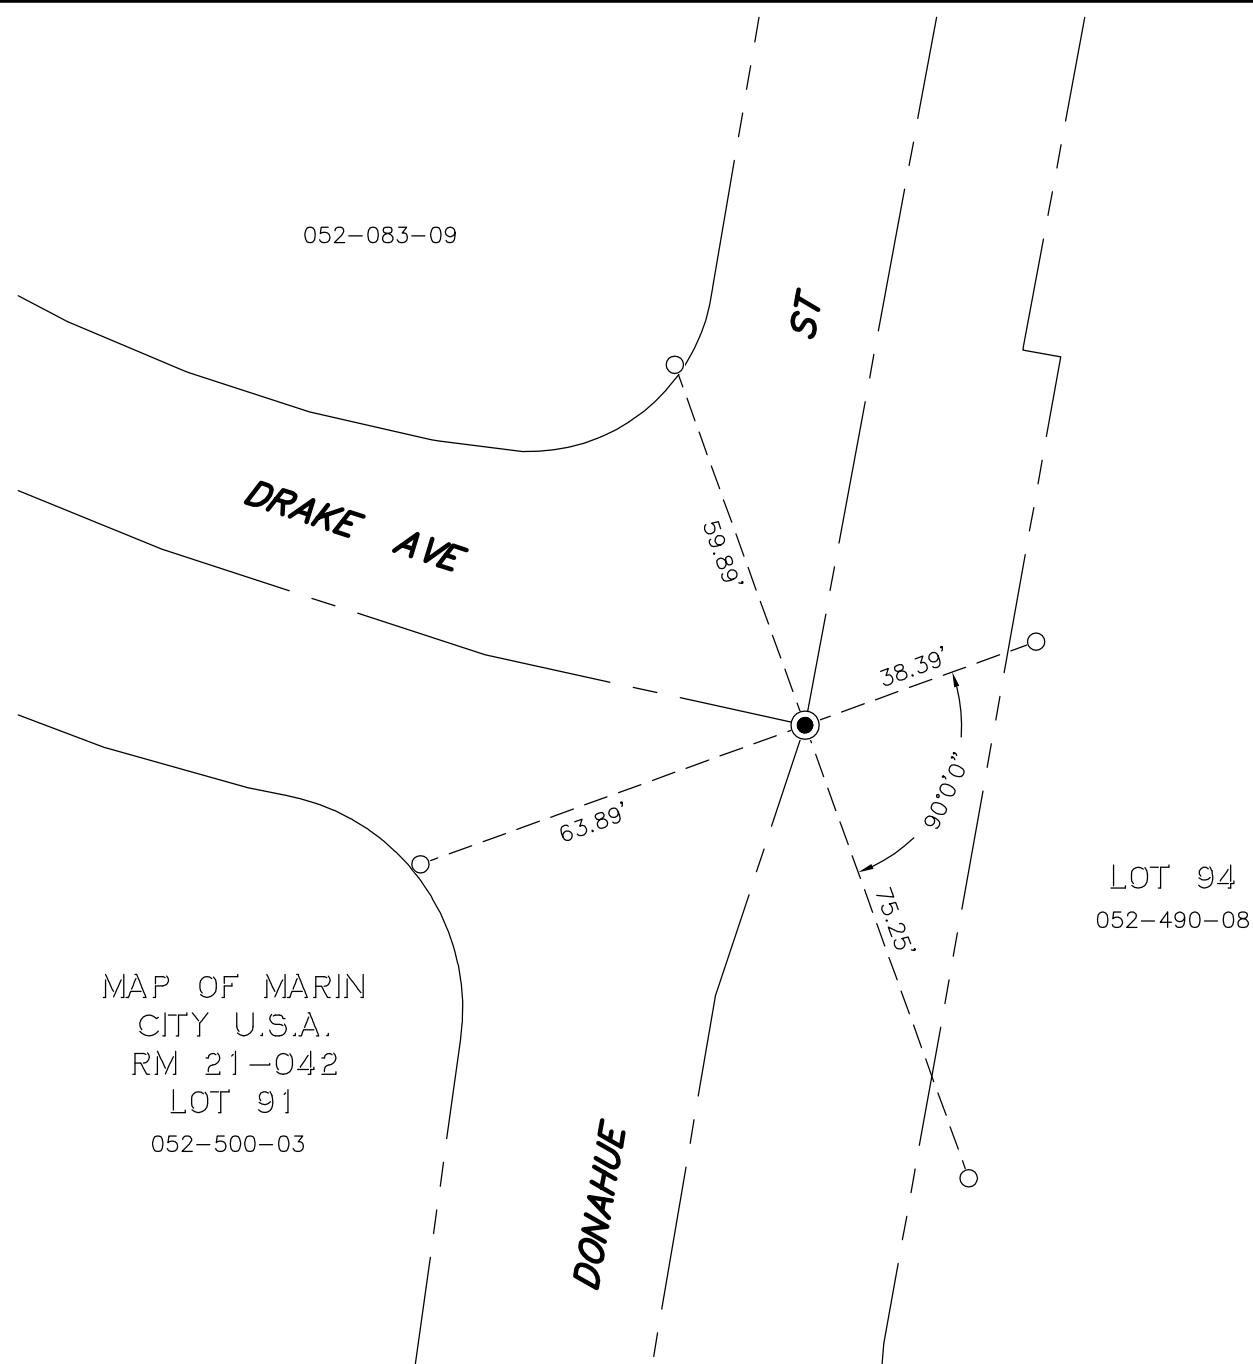
FOUND 6-INCH DIAMETER CONCRETE, BROKEN, IN MONUMENT WELL AT CENTERLINE INTERSECTION OF DRAKE AVENUE & DONAHUE STREET, AS SHOWN ON THAT RECORD MAP ENTITLED 'MAP OF MARIN CITY U.S.A.' FILED IN BOOK 21 AT PAGE 42, MARIN COUNTY RECORDS. SET FOUR 1/2-INCH IRON PIPES WITH YELLOW PLASTIC PLUGS STAMPED PLS 8614 AS REFERENCE POINTS TO PRESERVE THE CENTER OF THE FOUND CONCRETE MONUMENT PRIOR TO WATERLINE CONSTRUCTION.

- FOUND 6" DIAMETER  
CONCRETE, BROKEN, IN  
MONUMENT WELL,  
REFERENCED CENTER
- SET 1/2" IRON PIPE WITH  
YELLOW PLASTIC PLUG  
TAGGED PLS 8614
