# CORNER RECORD

City of Vicinity of San Rafael

Document Number 180-042-28

County of MARIN, California

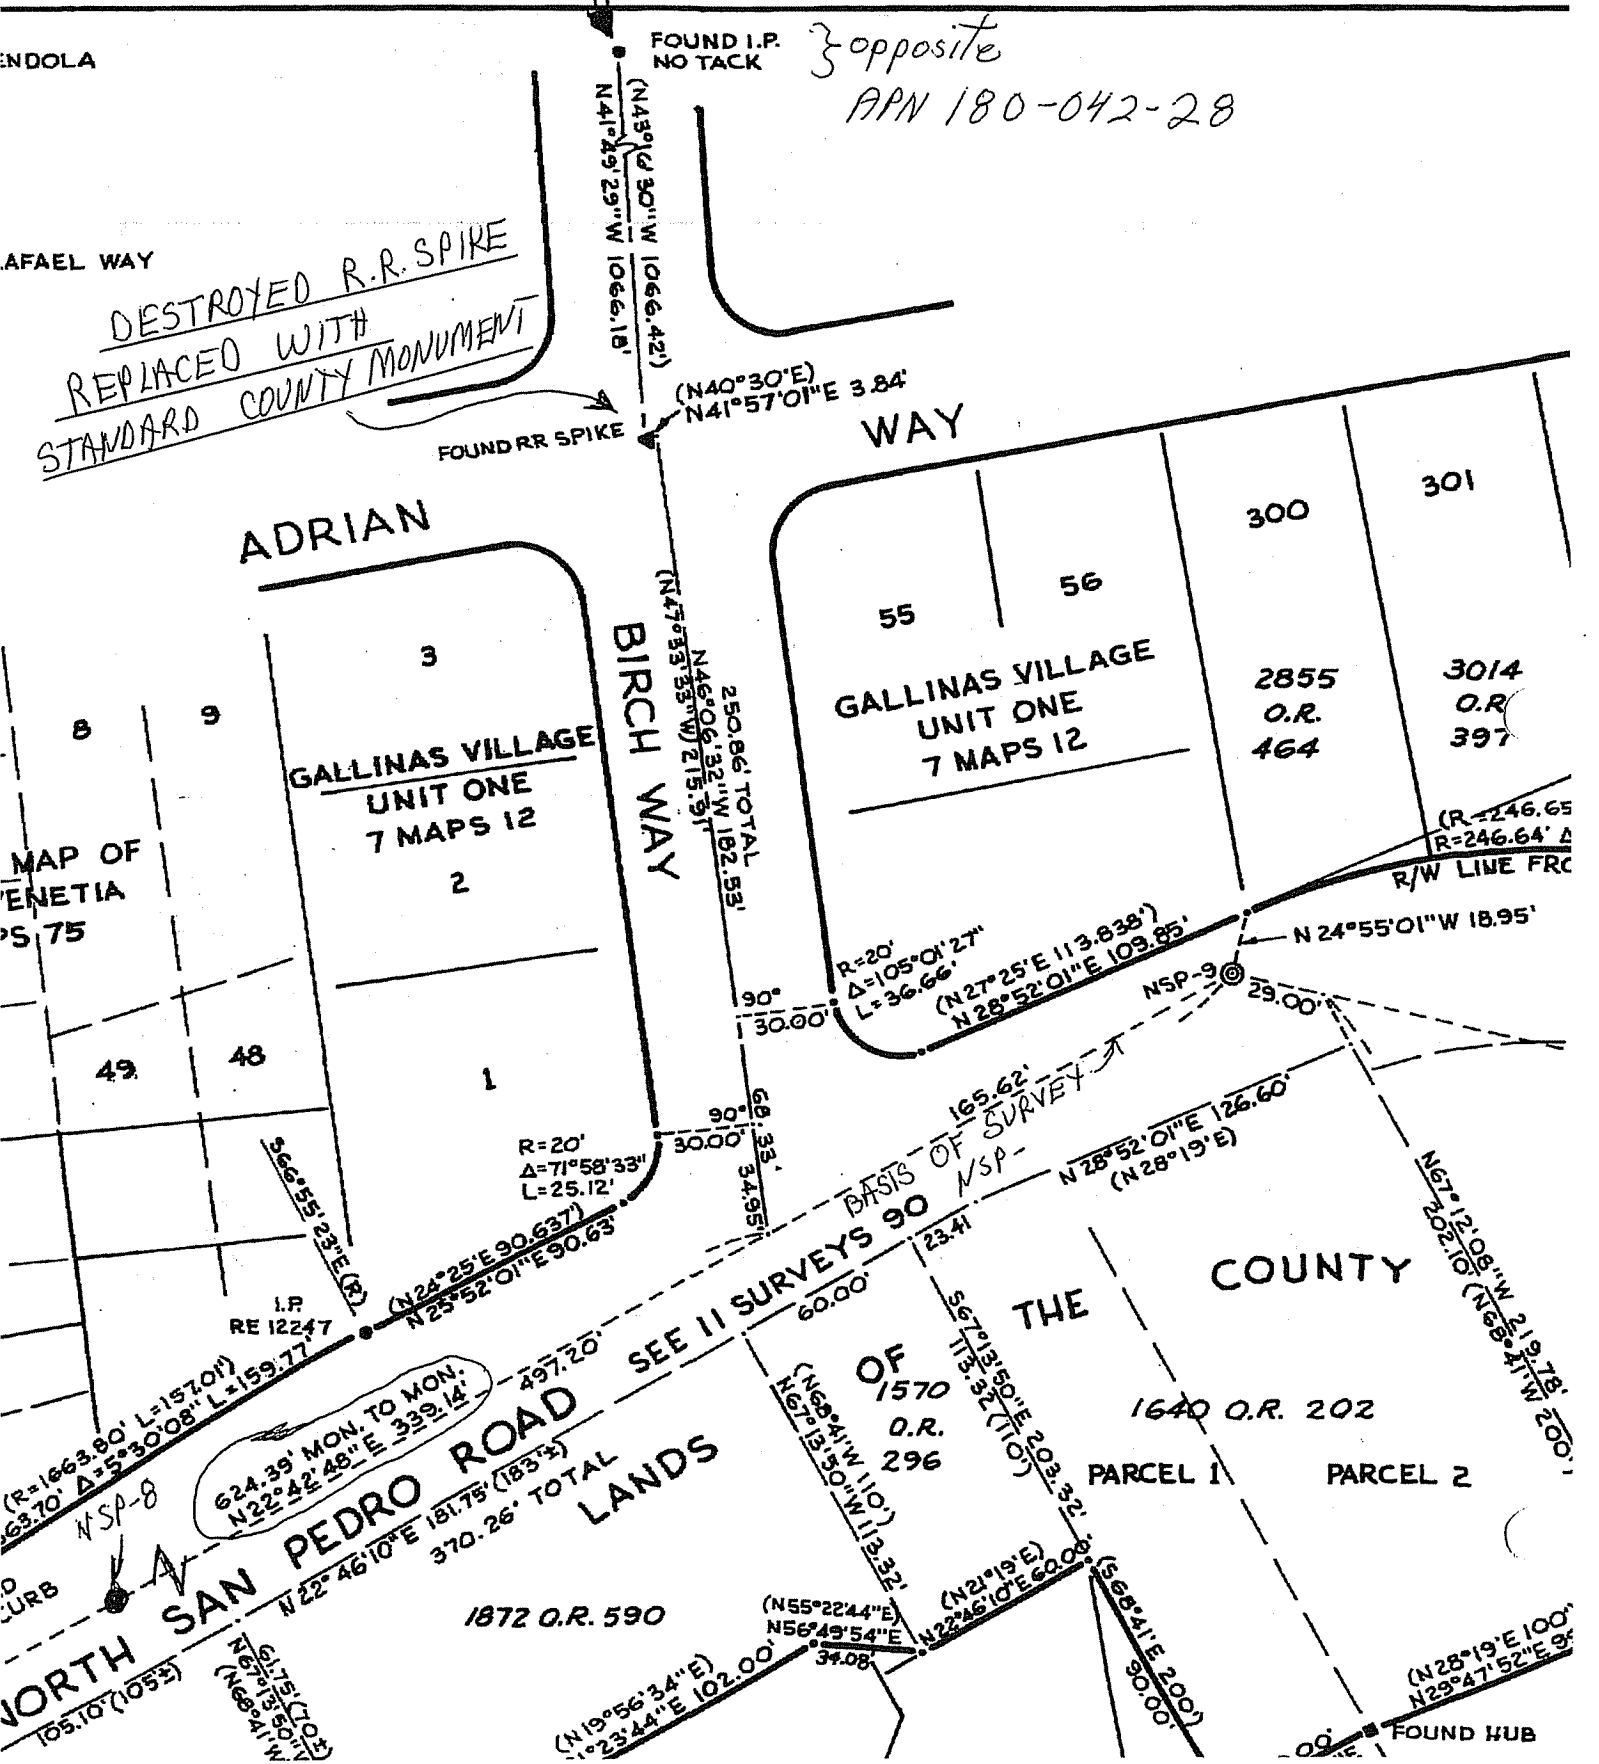
Sheet 7 of 8

Iron Pipe on Birch Way, and the Railroad Spike at  
Intersection of Birch Way and Adrian Way were destroyed  
during sewer construction.

DISTURBED I.P. REPLACED  
WITH STANDARD COUNTY MONUMENT

DESTROYED R.R. SPIKE  
REPLACED WITH  
STANDARD COUNTY MONUMENT

Replaced Iron Pipe and railroad spike in positions  
shown on 15 O.S. 36, with  
Standard County Monument  
see back
