# CORNER RECORD

Agency Index CR24-145Document Number APN 001-215-20City of Fairfax County of Marin, CaliforniaBrief Legal Description Portion of Rocca Drive right of way as shown on 2023 Maps 93, MCR**CORNER TYPE****COORDINATES (Optional)**

THE PURPOSE OF THIS BOUNDARY SURVEY IS TO ESTABLISH THE RIGHT OF WAY LINE FOR THE CONSTRUCTION OF A NEW RETAINING WALL AND NOT FOR ANY CERTAIN PARCEL.

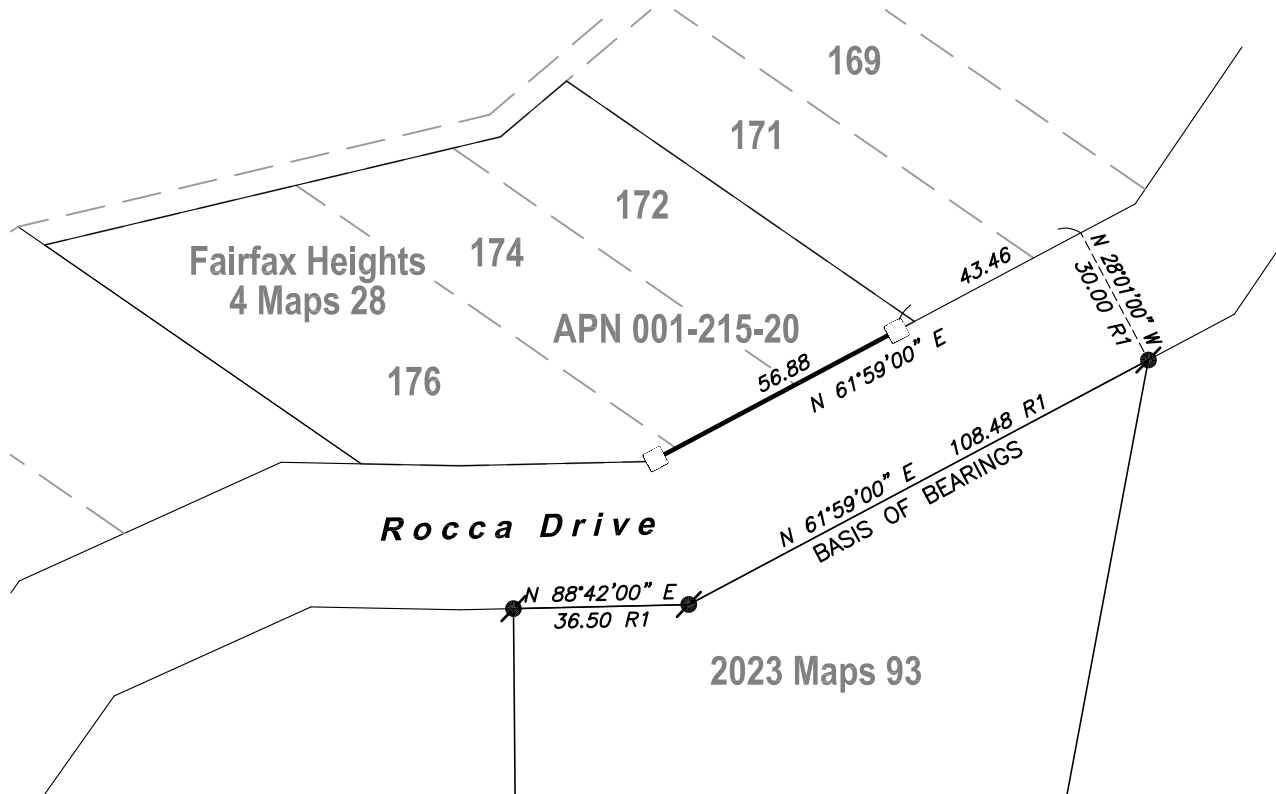
Found 1/2 inch iron pipes, plastic cap tagged 8155 marking the southerly right of way of Rocca Drive, held. Set 2x2 wood hubs with brass nail & tag 7950 marking a portion of the northerly right of way.
